February 13, 2015

BEL 213436

**Re: Tree Inventory and Preservation Plan – Waldemar Property**

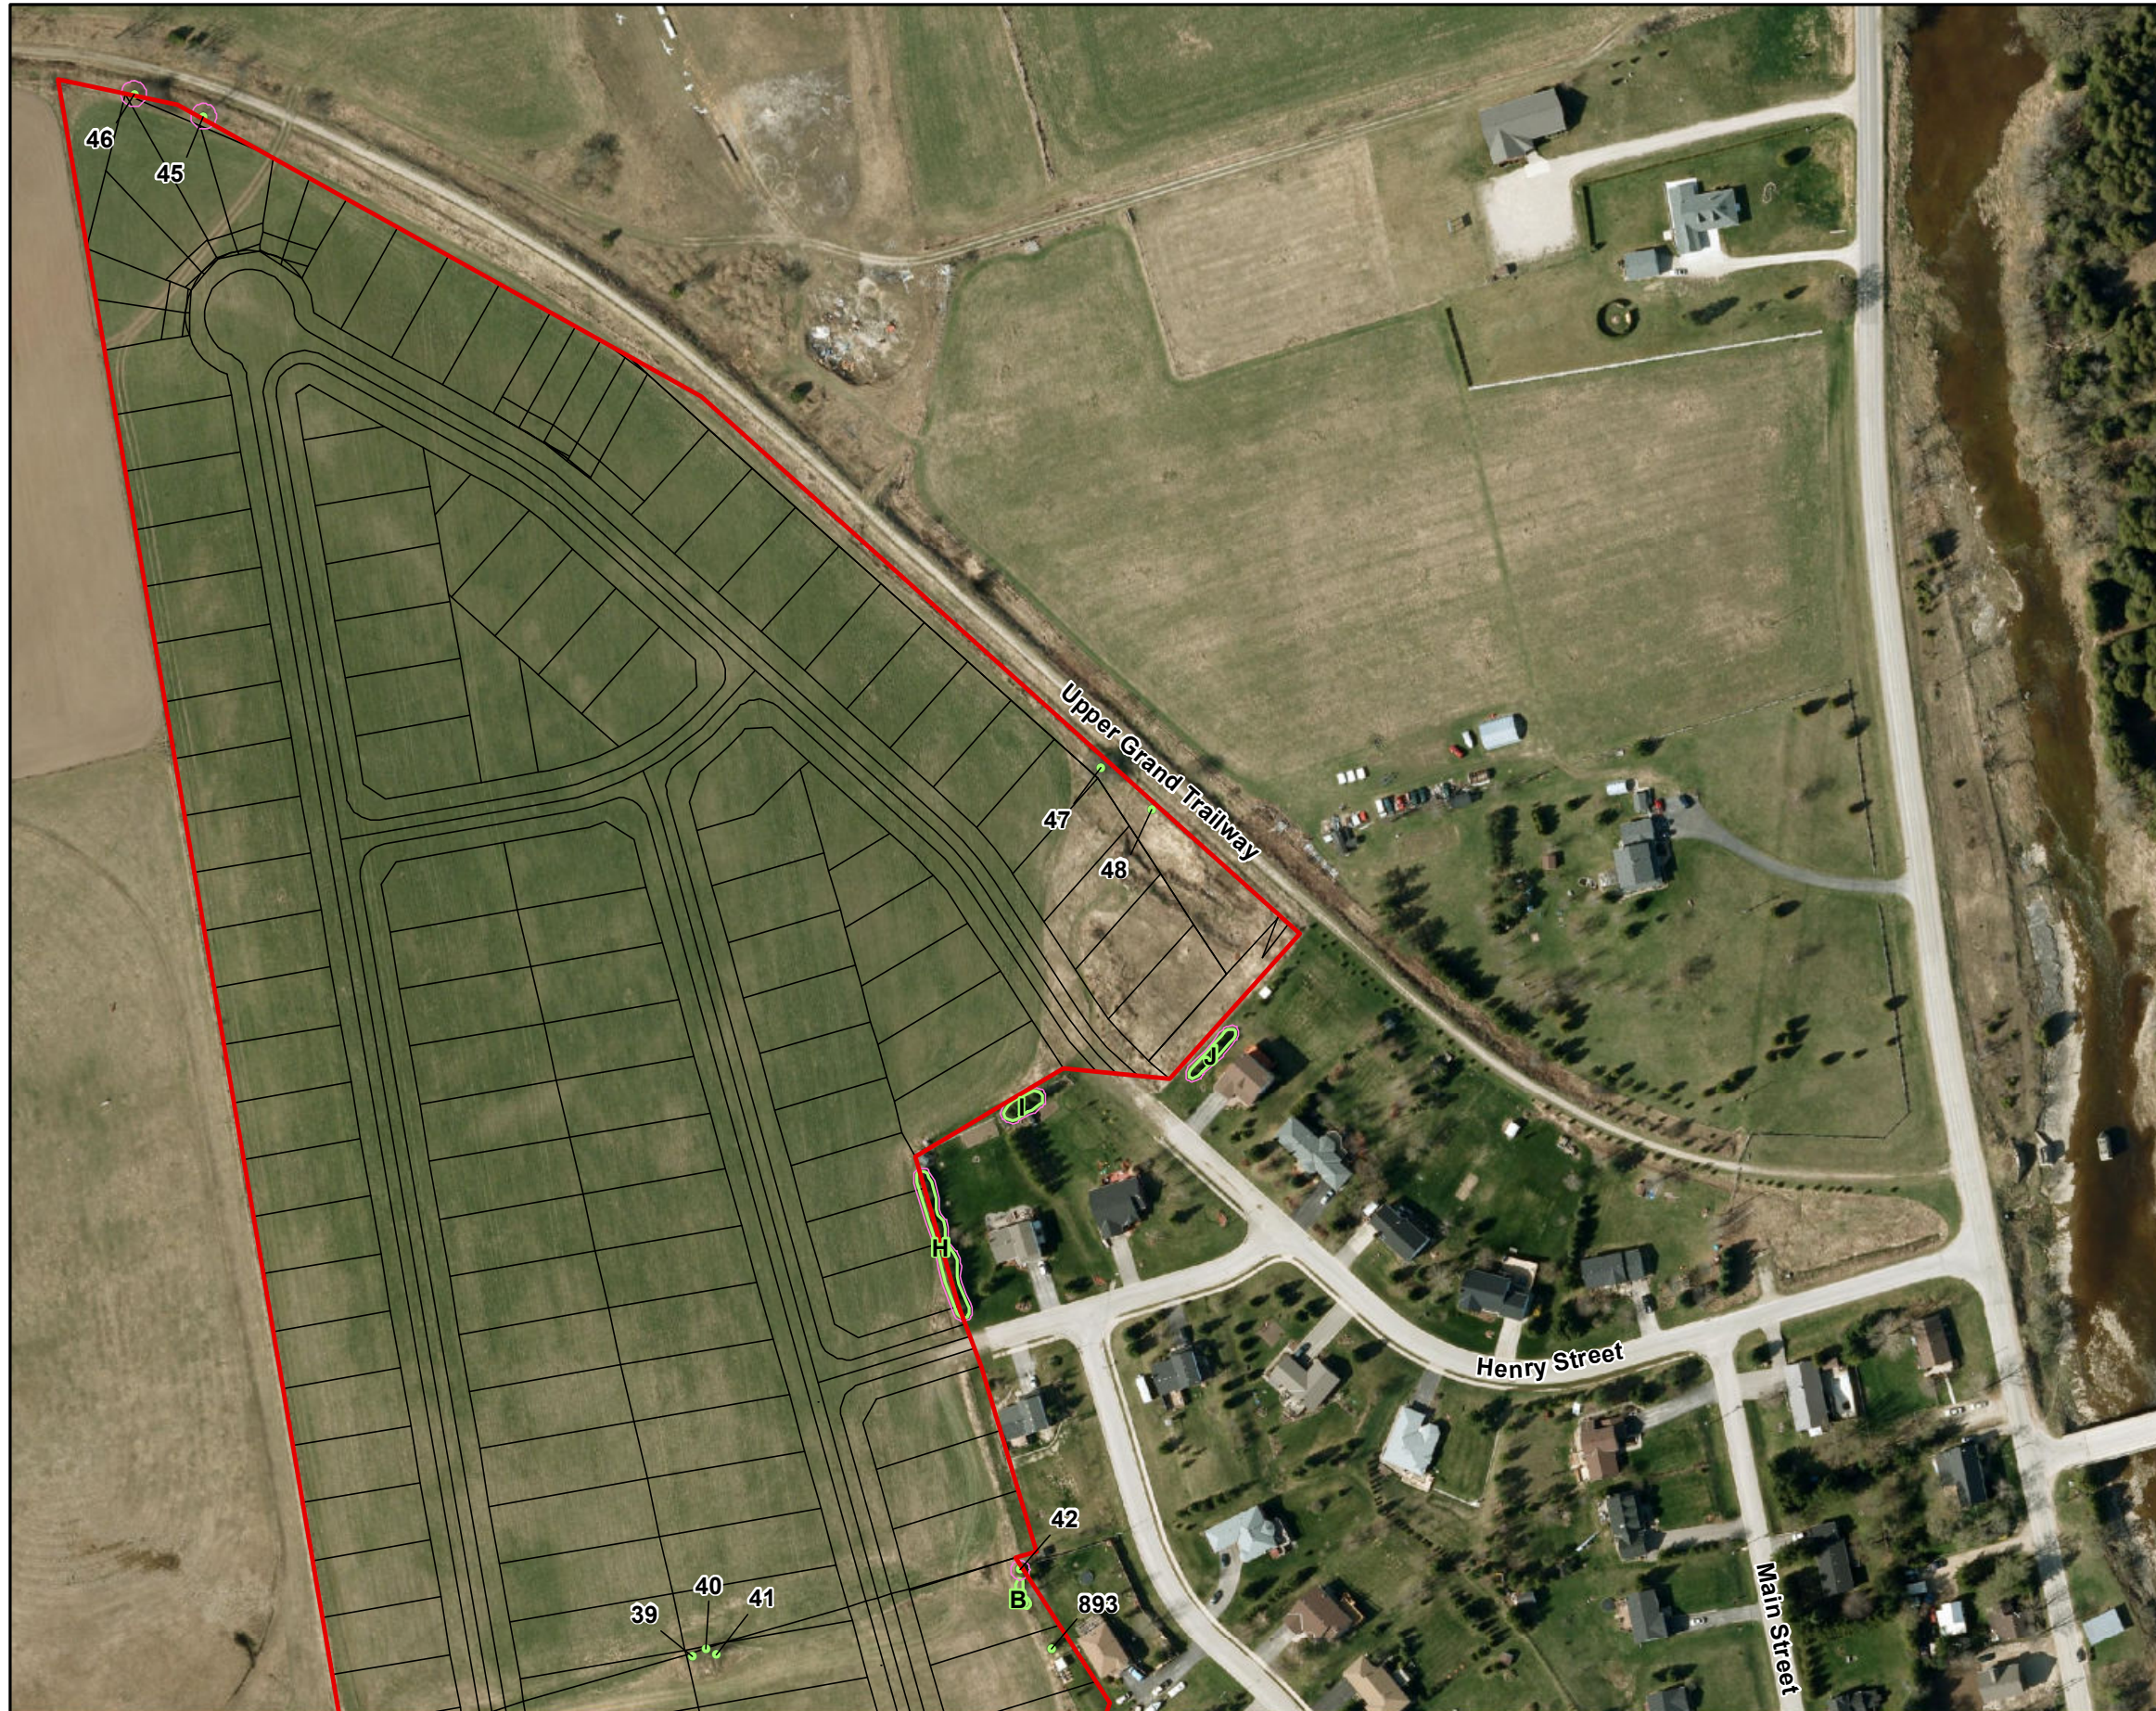
## Figure 2a

In addition to the individual trees that were inventoried and assessed, 10 tree groupings that were delineated and characterized. The tree groupings are generally situated at the periphery of the subject property (see **Figure 2**). A description of the tree groupings is provided below.

Trees to be retained shall be protected through the establishment of a Tree Protection Zone (TPZ). The TPZ shall be established at the dripline of individual trees and one meter from the edge of tree groupings (see **Table 2** and **Figure 2**).

Erosion and Sediment Control (ESC) fencing, which will be established at the limit of development, shall also function as tree protection fencing for those trees and tree groupings identified for preservation. The limit of the ESC fencing will demarcate the TPZ (see **Figure 2**).
